Anytime, 2011

Location: 122 Anywhere Rd  
Columbus OH 43235

Evaluate: Leaking Foundation Walls

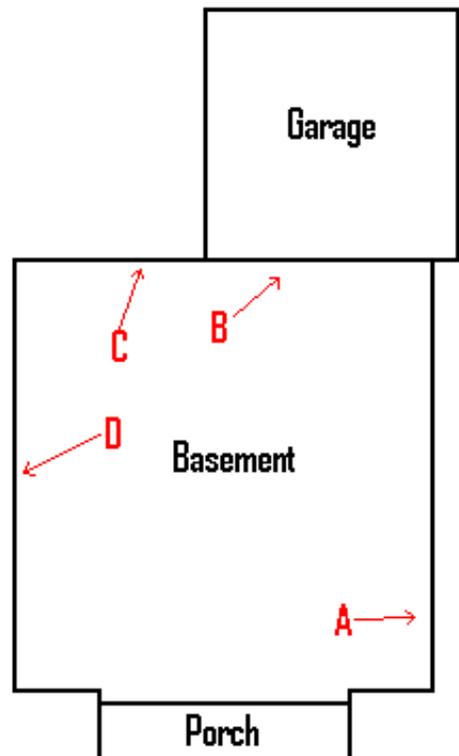
I have marked the areas in question on the foundation labeled A, B, C and D. Drawing of foundation is not to scale.

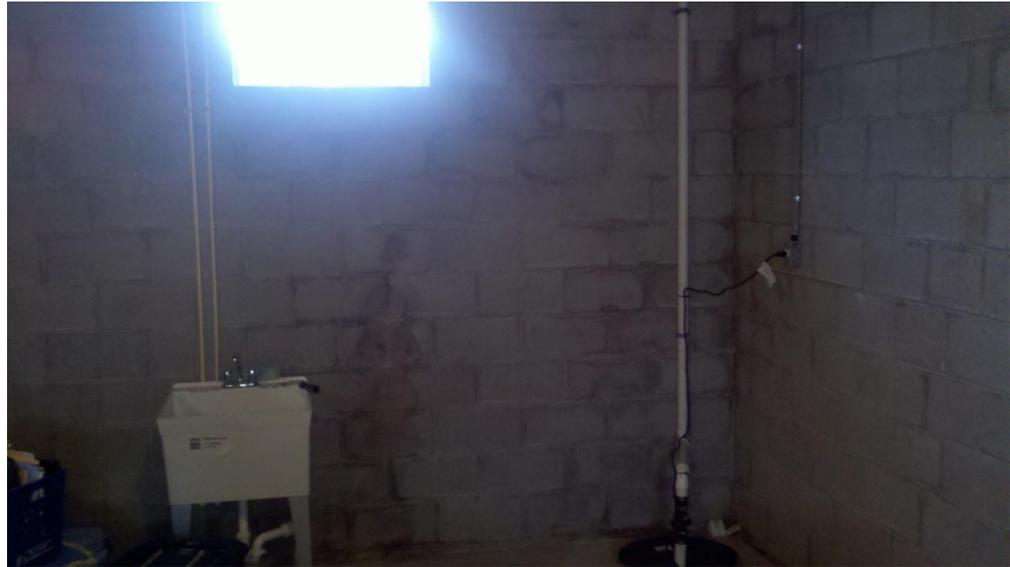
### ***INTERIOR Observation A***

There is noticeable staining on the wall in this area. The staining starts approximately 3 courses down from the bottom of the window. There is noticeable staining on the wall from the above grade block beside the window as well.

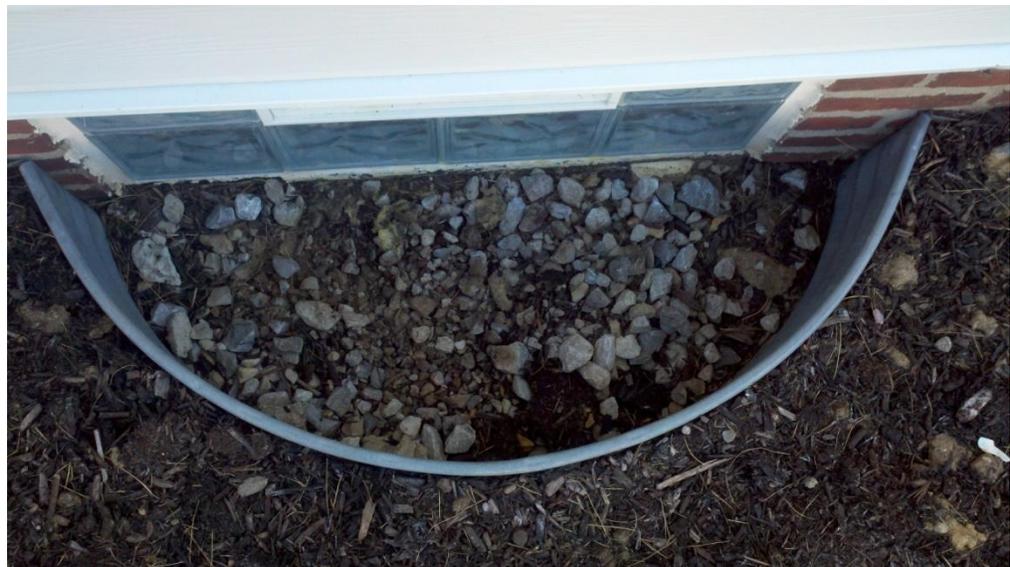
### ***EXTERIOR Observation A***

The grade inside the window well is a little high being level with the bottom of the window.

There needs to be proper drainage for the window well. Typically there is a drain tile or gravel from the window well down to the exterior drain tile to properly drain the water away.

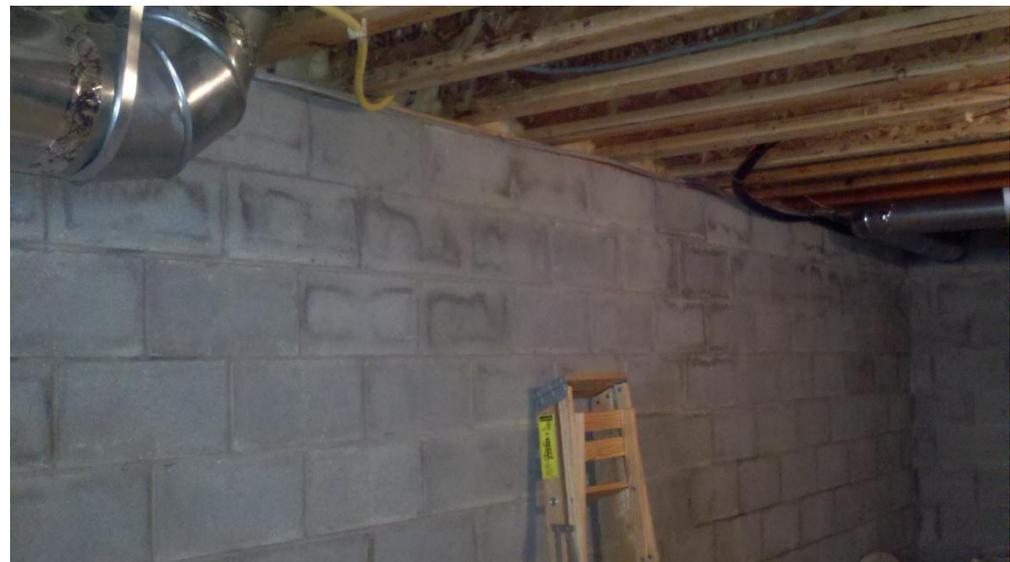
### ***INTERIOR Observation B***

There is noticeable staining on the top two-three courses. This is on the interior garage wall. Staining is well above the exterior waterproofing.

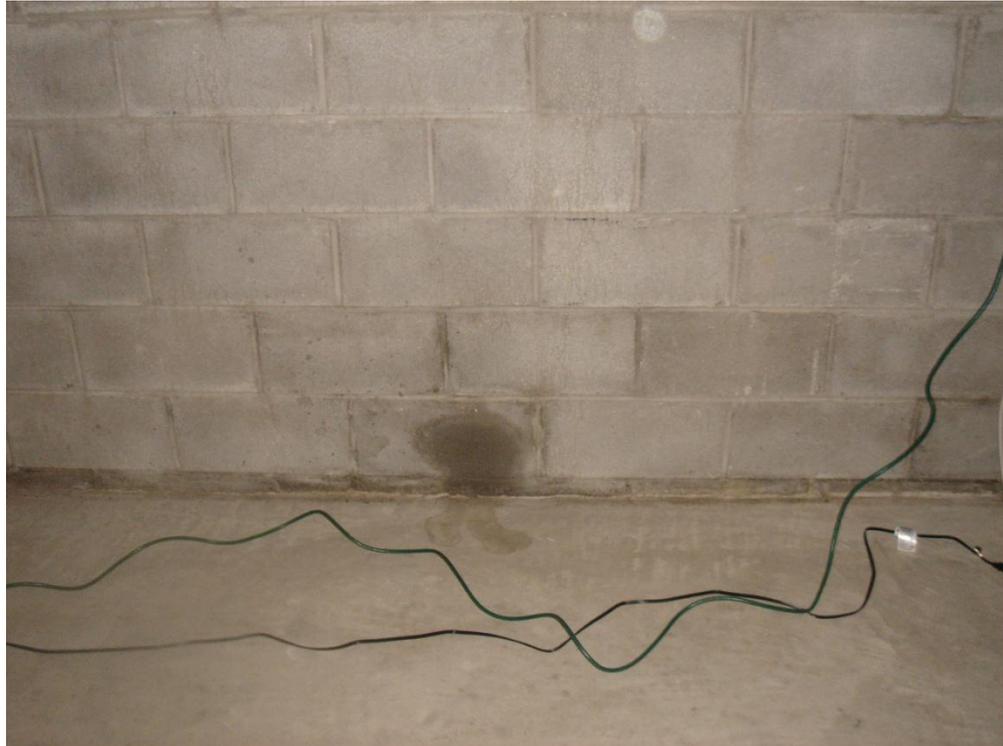
### ***INTERIOR Observation C***

There is staining at the base of the floor where it meets the wall. This typically indicates a blocked weep hole below the floor.

Remove basement floor in this area and clear the weep hole so it drains properly

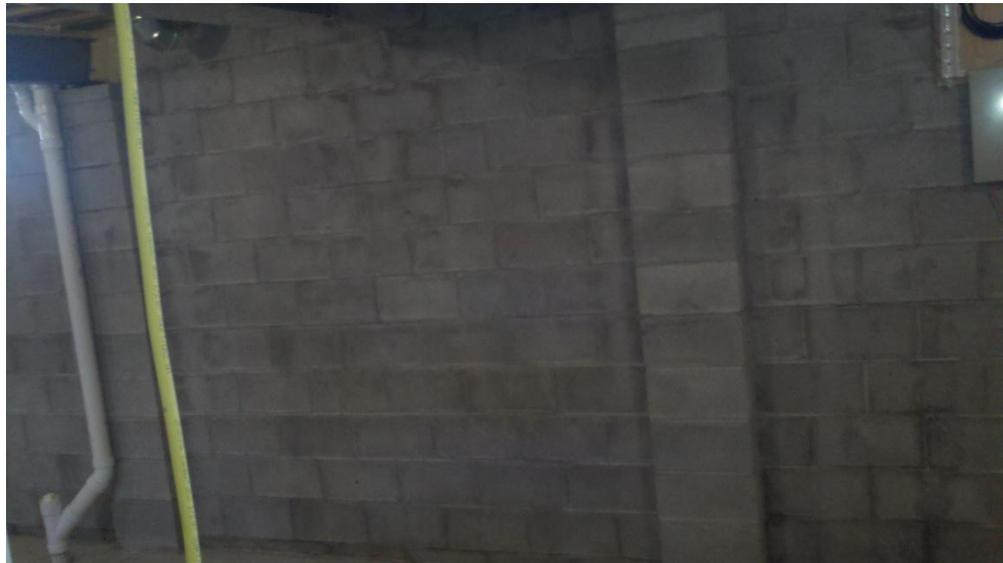
### ***INTERIOR Observation D***

There is staining at the top three courses. This typically indicates leakage through the above grade block/brick veneer.

Seal the above grade brick veneer. Ensure the below grade waterproofing is at the top of the exterior grade. As well ensure the grade slopes away from the home.
