Anytime, 2011

Location: 122 Anywhere Rd  
Columbus OH 43235

Evaluate: Leaking Foundation Walls

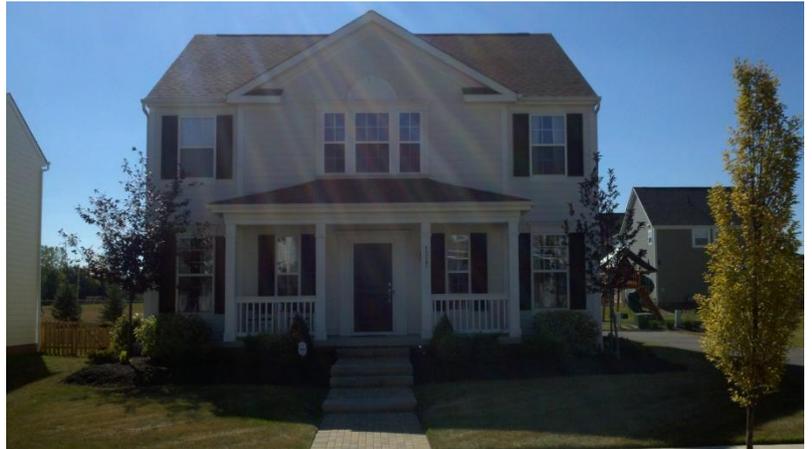
The front of the home faces east, with an attached garage on the west side of the home, facing north. The main entrance to the home is located on the east side of the home. The north, west and south (unfinished) basement/foundation walls were evaluated. The structure was constructed in 2009 on an 8'-8" foot tall 8" thick block wall foundation by MI Homes.
